# A Space Shuttle Story

## Stephen Coester '63

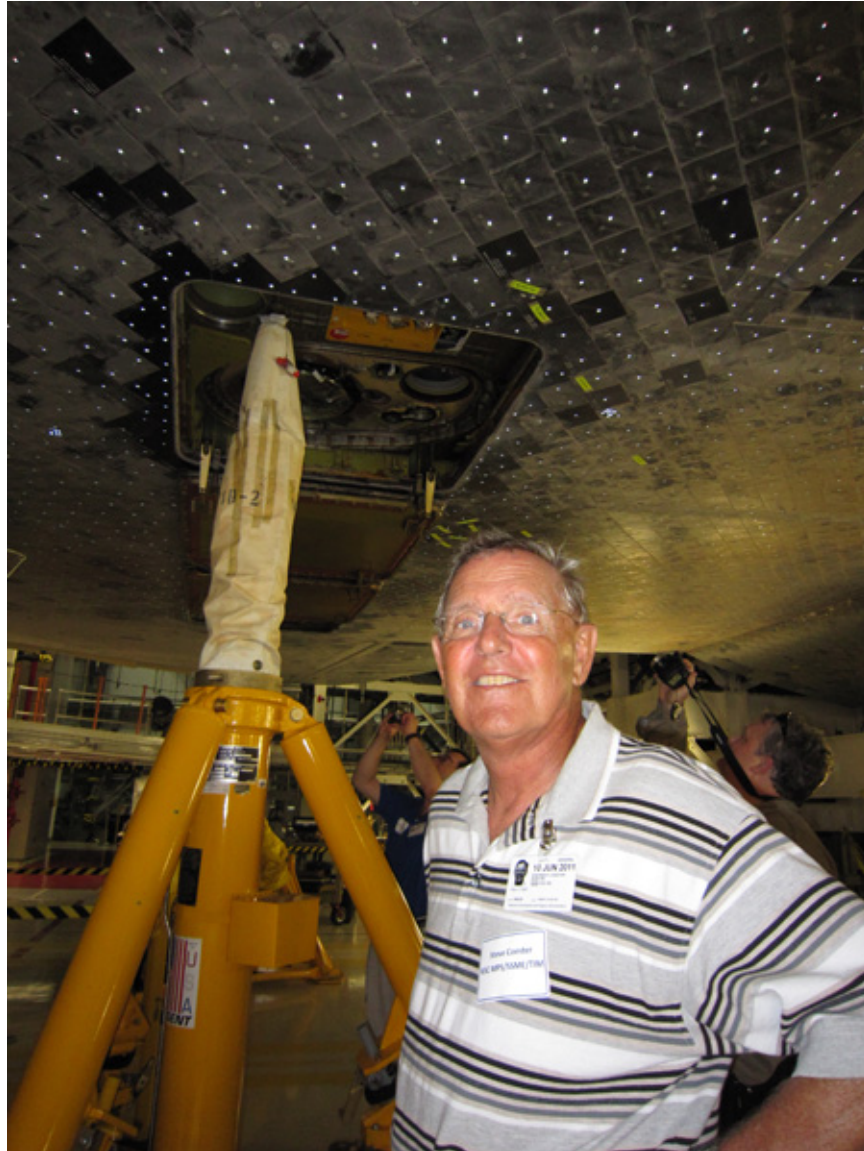
liquid hydrogen. The LOX plate on the orbiter is shown and mates to a similar plate on the external tank. The umbilicals are held together by three explosive bolts that go through the three holes around the large valve in the brown area shown in the photo.

This story concerns the smaller valve to the left in the photo. It is known as the Gaseous Oxygen two inch disconnect and its purpose is to direct high temperature, high pressure gas at 400 psig from the Space Shuttle Main Engines (SSME) to the top of the Liquid Oxygen tank to pressurize the LOX tank during flight. Here's a schematic of the two inch disconnect.
